UNDERWATER BRIDGE INSPECTION REPORT

STRUCTURE NO. 66523
MSAS 125 (HULET AVENUE)
OVER THE
CANNON RIVER
DISTRICT 6 - RICE COUNTY

PREPARED FOR THE
MINNESOTA DEPARTMENT OF TRANSPORTATION
BY
COLLINS ENGINEERS, INC.
JOB NO.5221

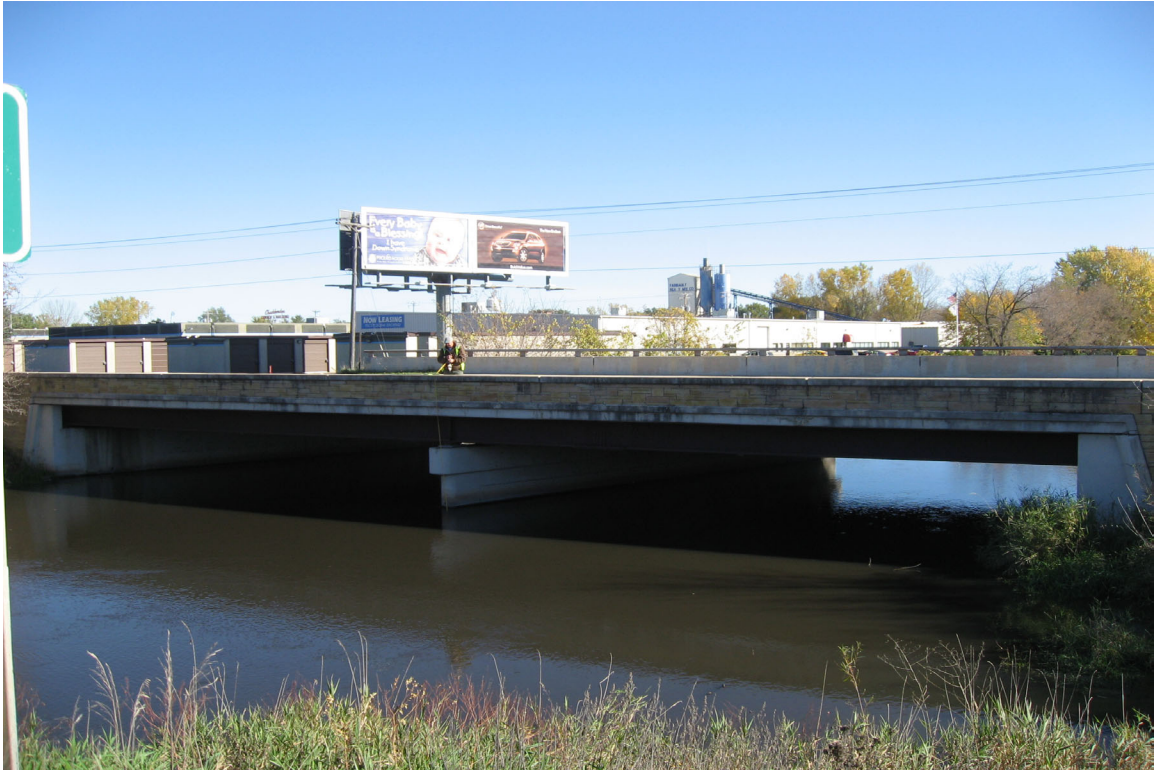
Photograph 1. Overall View of Bridge, Looking Northeast.

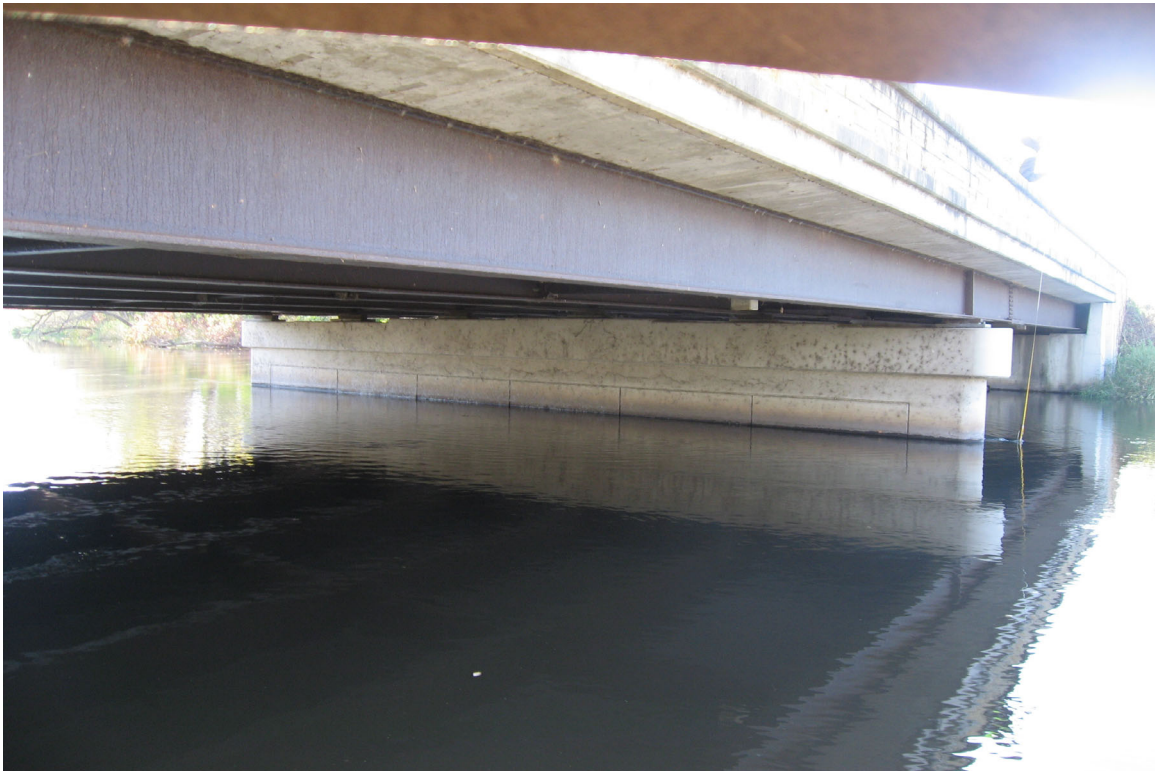
- (A) Concrete of all units was in good and sound condition with no notable deterioration.
- (B) A light accumulation of timber debris consisting of 1-foot-diameter and smaller logs and branches was observed on the channel bottom at the upstream end and along the northern downstream half of Pier 1.

Photograph 2. View of Pier 1, Looking Southeast.

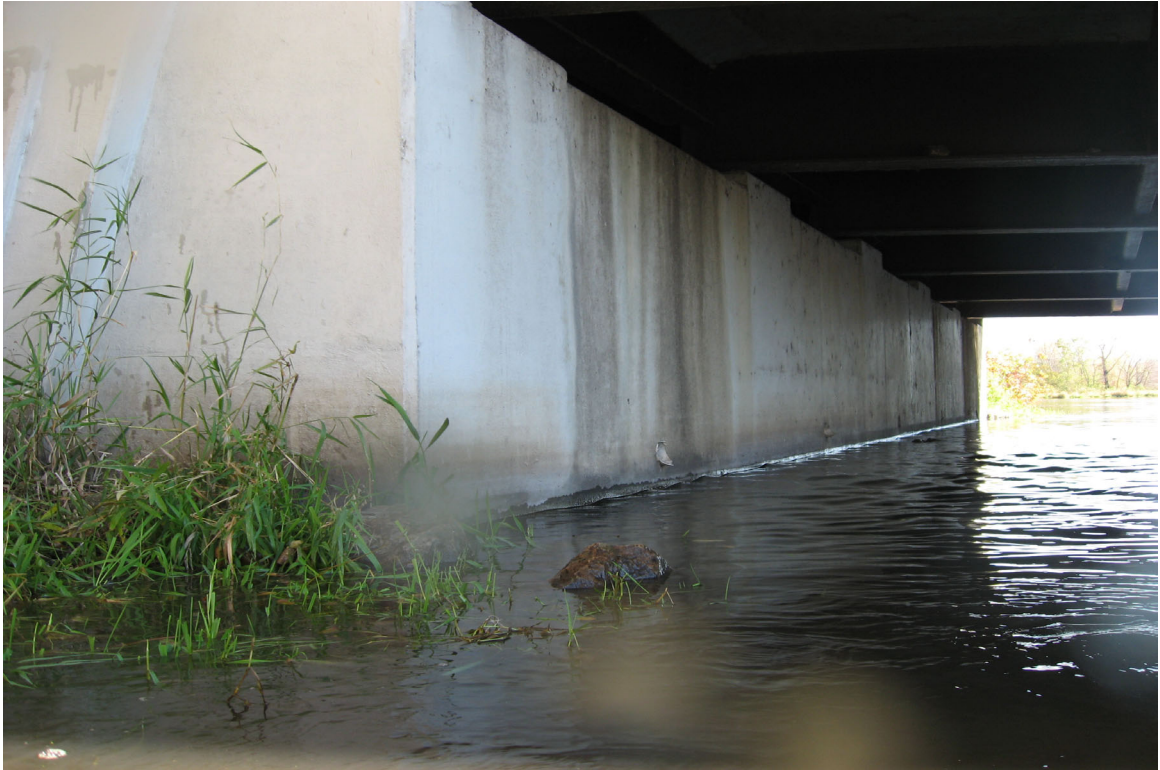
Photograph 3. View of the North Abutment, Looking Northeast.

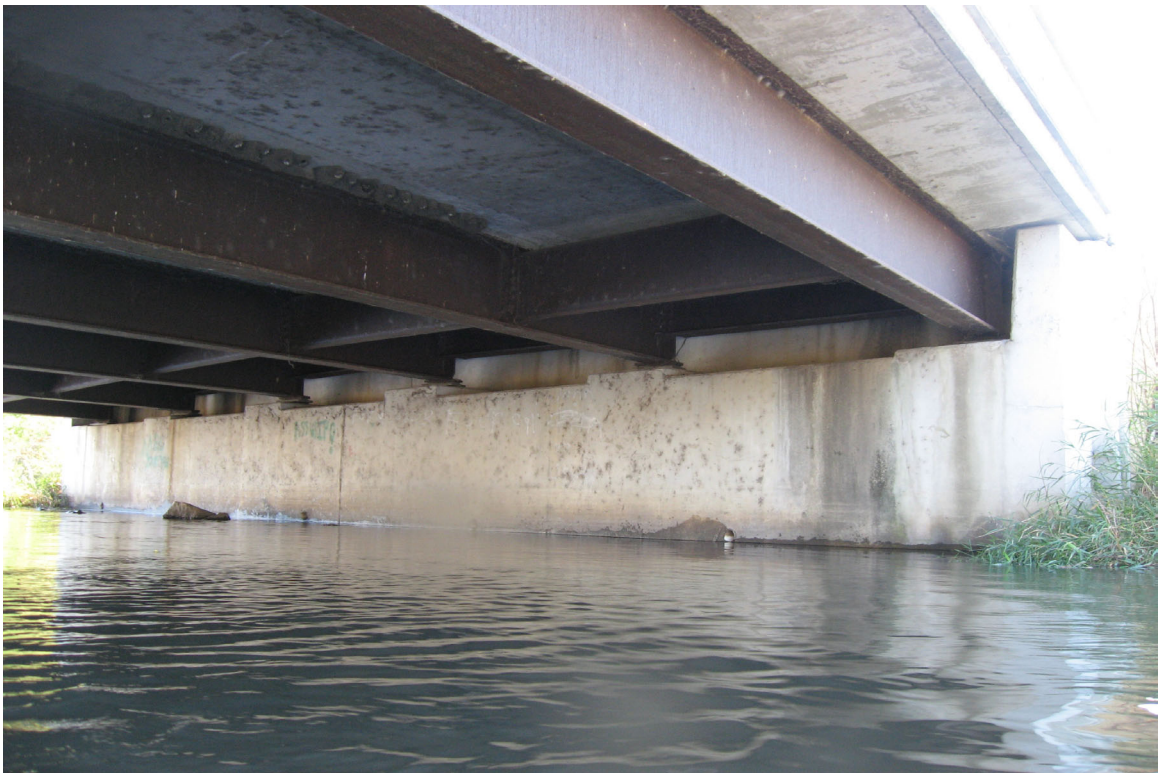
Photograph 4 View of the South Abutment, Looking Southeast.

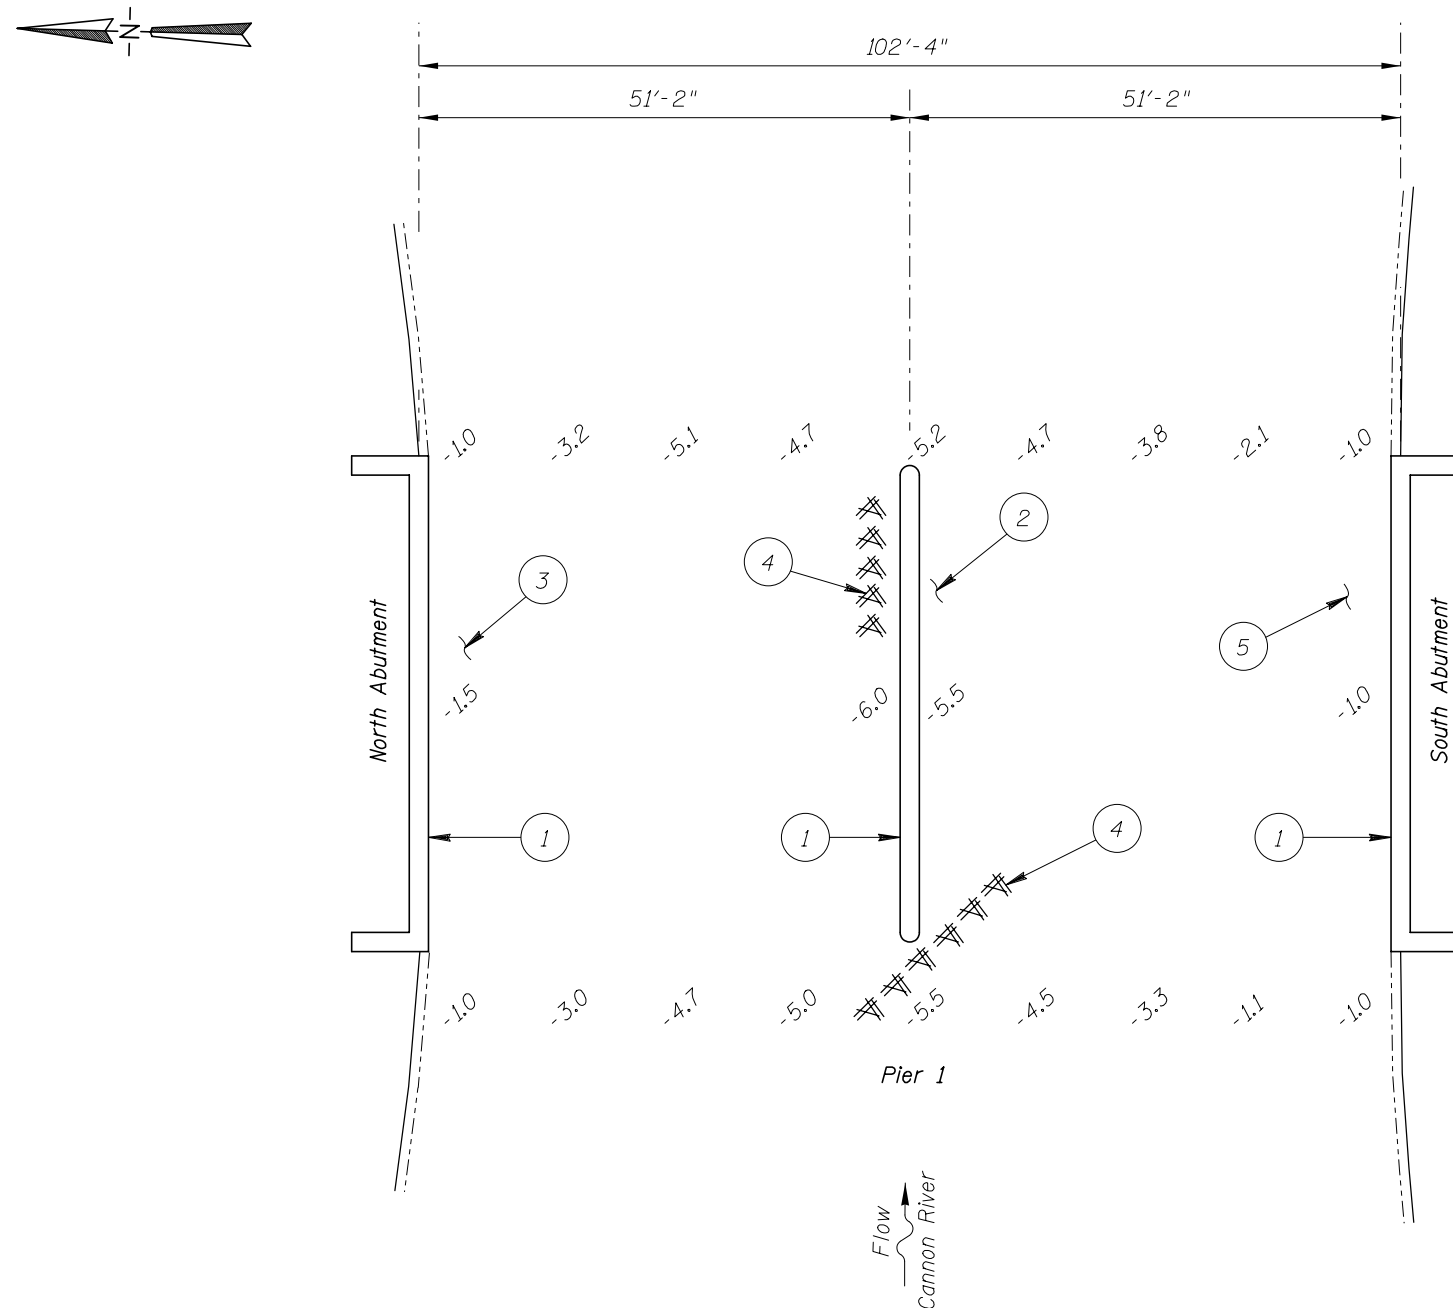
SOUNDING PLAN

- 1 The concrete was in smooth and sound condition with no notable deterioration.
- 2 The channel bottom at Pier 1 consisted of silty sand with scattered rock and up to 2 inches of probe rod penetration.
- 3 The channel bottom along the North Abutment consisted of 2-foot-diameter and smaller riprap.
- 4 A light accumulation of timber debris consisting of 1-foot-diameter and smaller logs and branches was observed on the channel bottom at the upstream nose and along the northern downstream half of Pier 1.
- 5 The channel bottom along the South Abutment consisted of 4-foot-diameter and smaller riprap.
